TEST REPORT

Name of product: Standing mailbox

Report number: SZQLAB-20251738A

Suzhou SZQ Testing Co., Ltd.

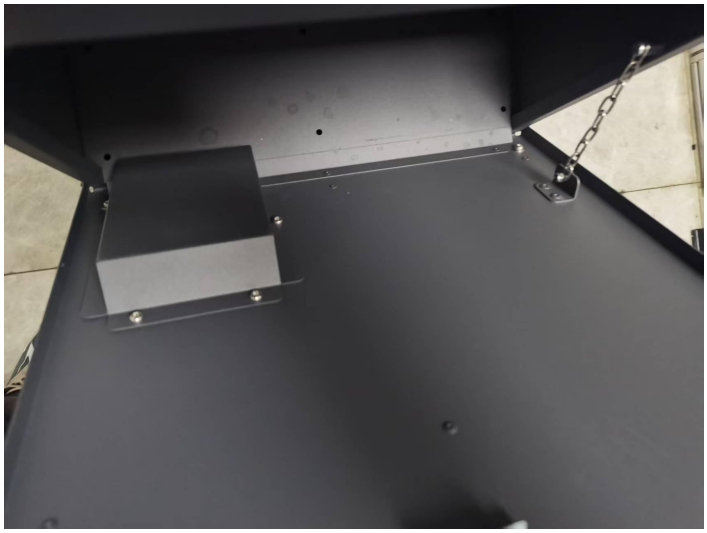
After IPX4 test Photo
