TEST REPORT

Name of product: Standing mailbox

Report number: SZQLAB-20251739A

Suzhou SZQ Testing Co., Ltd.

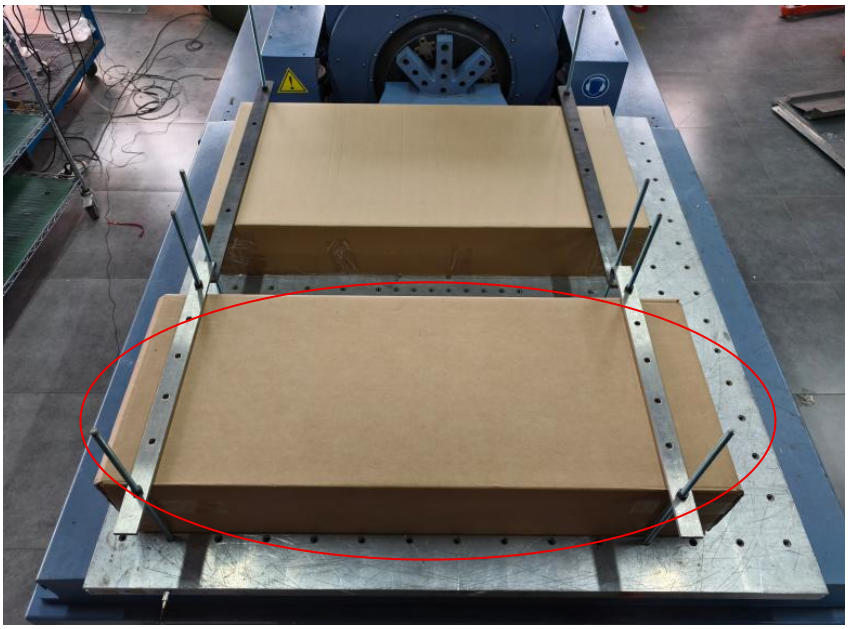
X-axis random vibration test Photo（The red circle indicates the sample for this test.）

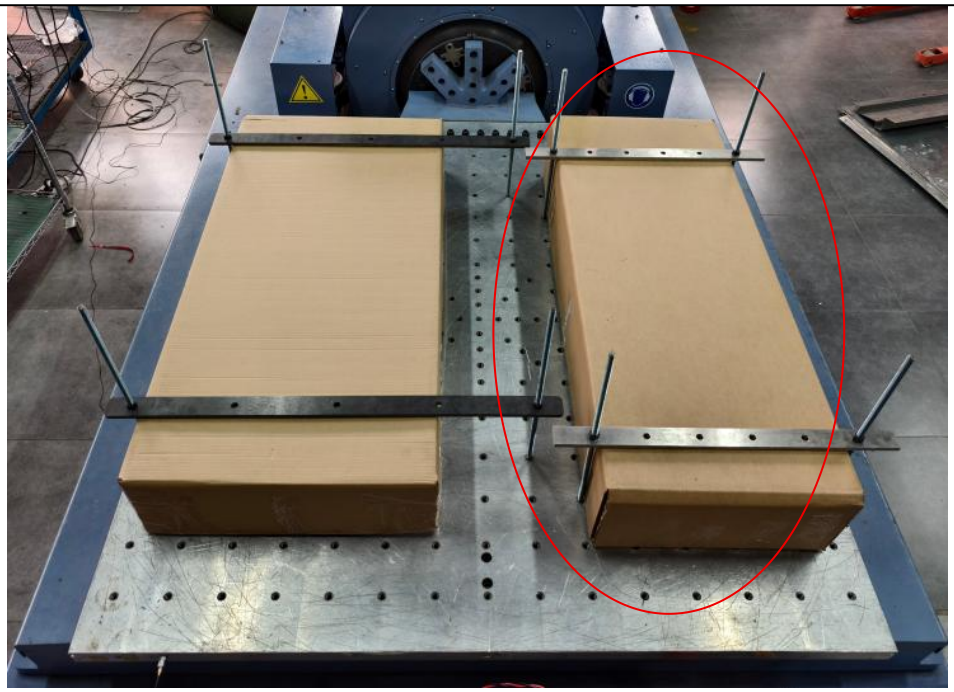
Y-axis random vibration test Photo（The red circle indicates the sample for this test.）

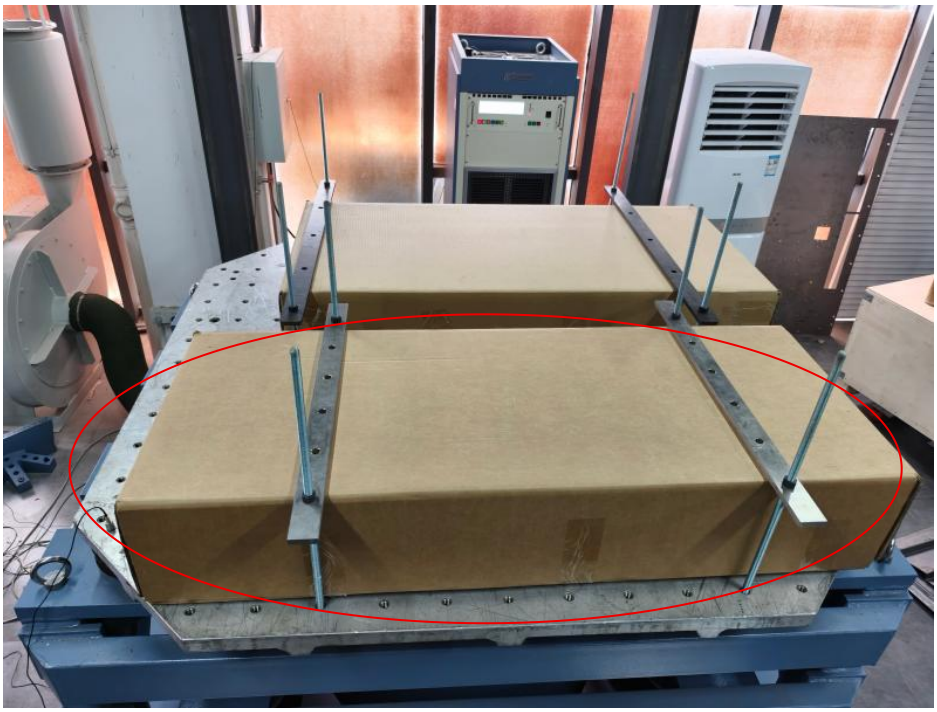
Z-axis random vibration test Photo（The red circle indicates the sample for this test.）
